Concerning the provenance of this vehicle, my restorer, Mr. Shooter Newton, searched for a chassis number after I acquired it from the previous owner, Russell Yordy who was a collector of four matching number Duesenbergs and four Duesenberg IIs over his lifetime, who had already made the engine, suspension and drive train modifications and found none accessible.

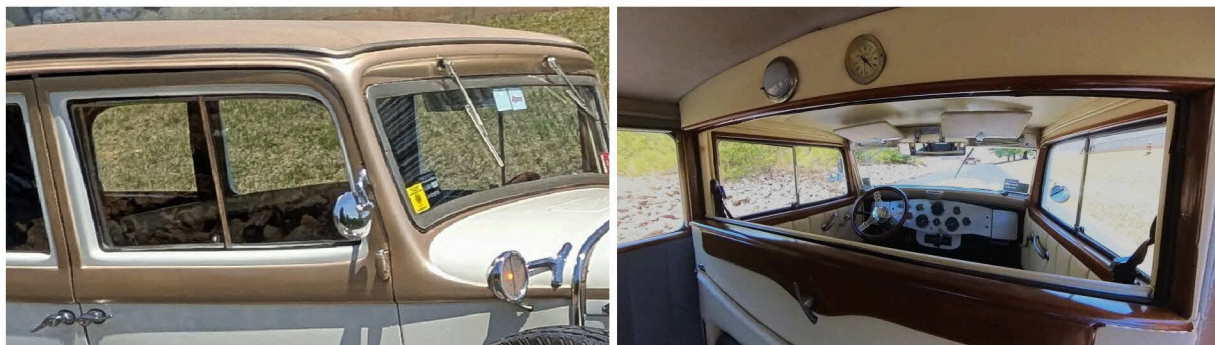
Uploading the images below I asked, ***Do you know of any 1930's limousine coachbuilder who had the front door windows split vertically down the middle and swing out to open instead of rolling down into the door? and did they build coach bodies for both Duesenberg and Packard?***

[Gemini.AI](#) replied: That is a brilliantly specific design detail. The unique setup shown in the image—where the front chauffeur's window is vertically split down the center and manually swings or cranks outward like dual wind-out windscreens—was a hallmark of The Rollston Company (later Rollson), a highly prestigious coachbuilder based in New York City.

While standard bodies utilized traditional roll-down windows, Rollston introduced this highly specialized vertical-split arrangement in the early 1930s for their formal town cars and limousines.

**The Purpose:** In ultra-formal town cars, the chauffeur's compartment was often open to the elements or covered by a removable leather canopy. When fully closed, standard rolling windows required bulky internal door mechanisms that interfered with the sleek, thin-door architecture Rollston favored. By splitting the glass vertically and hinging it to swing outward, they could provide ventilation without taking up space inside the door structure, keeping the lower door lines incredibly clean.

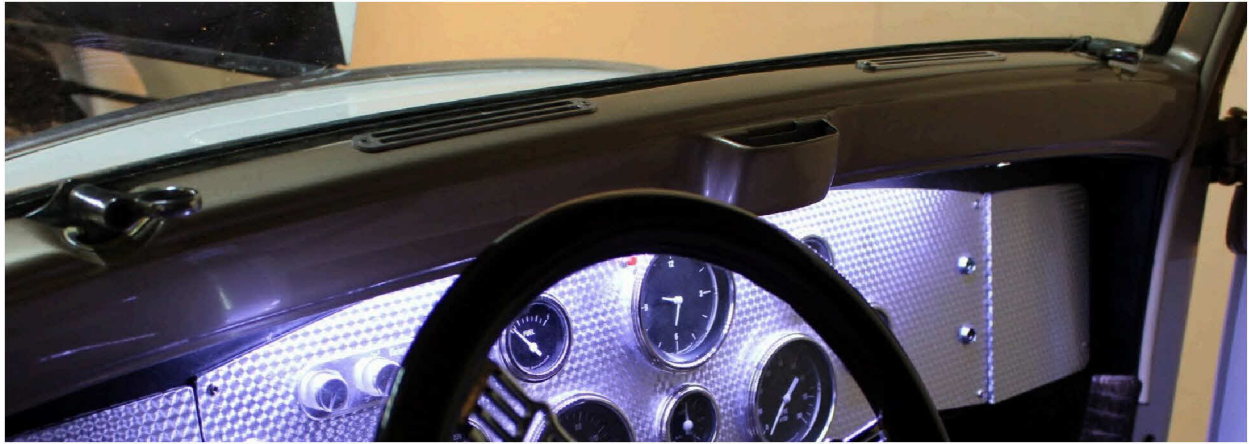
***Notice the 2 locking mechanisms on either end on top of the dash. They allow the windshield to be pushed away from the dash at the bottom. Was this also a feature of a Rollston Coach?***

**The Mechanism:** The dual brackets/locking T-handle mechanisms you see at the corners of the dash frame are connected to robust scissor links or sliding quadrant bars. Twisting or releasing these mechanisms unlatched the bottom of the heavy, chrome-framed windshield glass, allowing the driver to manually slide or push the bottom outward by a few inches.

**The "Low-Pressure" Ventilation Effect:** Because the windshield was hinged at the top, pushing the bottom outward directed a smooth, controlled sheet of fresh air directly downward into the footwells and across the floorboards. This kept the driver and passengers cool via ambient air circulation while blocking rain from easily driving directly into the dashboard instruments.

While some high-end factory production cars of the 1930s adopted simpler center-crank windshield regulators (which pushed the window out from the center base), the dual corner-locking hardware shown here is typical of highly specialized, low-volume custom coachwork.

It allowed for a perfectly flush, unbroken exterior seal when closed, preserving the razor-sharp, aerodynamic cowl lines that Rollston was famous for matching to the rake of the doors. Seeing this mechanism alongside a magnificent engine-turned Duesenberg instrument cluster is a textbook look at 1930s bespoke engineering at its absolute finest.

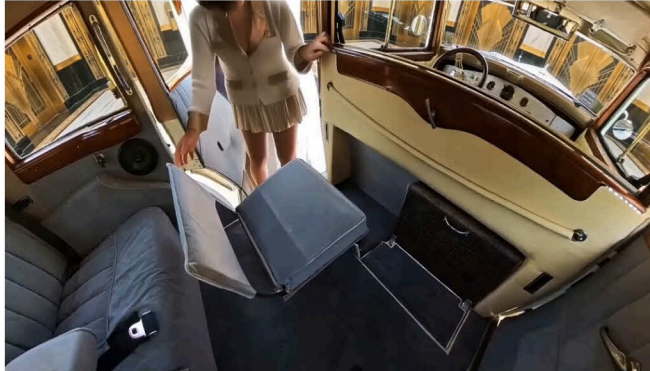
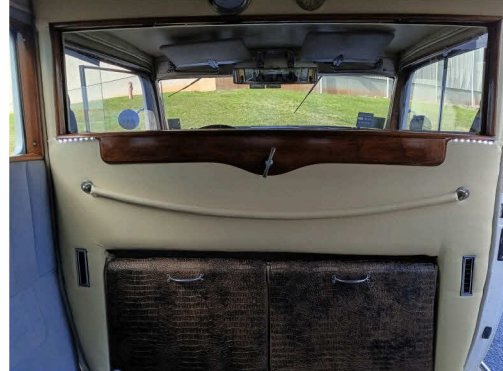
***Was this a signature type of jump seat that folded out from the center divider in a Rollston Formal Limousine? These are actual images from my car.***

[Claude.AI](#) replied: The original Rollston formal divider is fully intact and functional — roll-down division glass with walnut cap rail, and twin forward-facing jump seats that fold completely away into the divider face behind fitted crocodile-grain panels, preserving the rear saloon's clean formal appearance when stowed. Division-mounted jump seats were the most formal and structurally demanding execution of the era, requiring the cabinet-built divider construction Rollston was known for."
